Addendum to CH-47-05-SOF-02

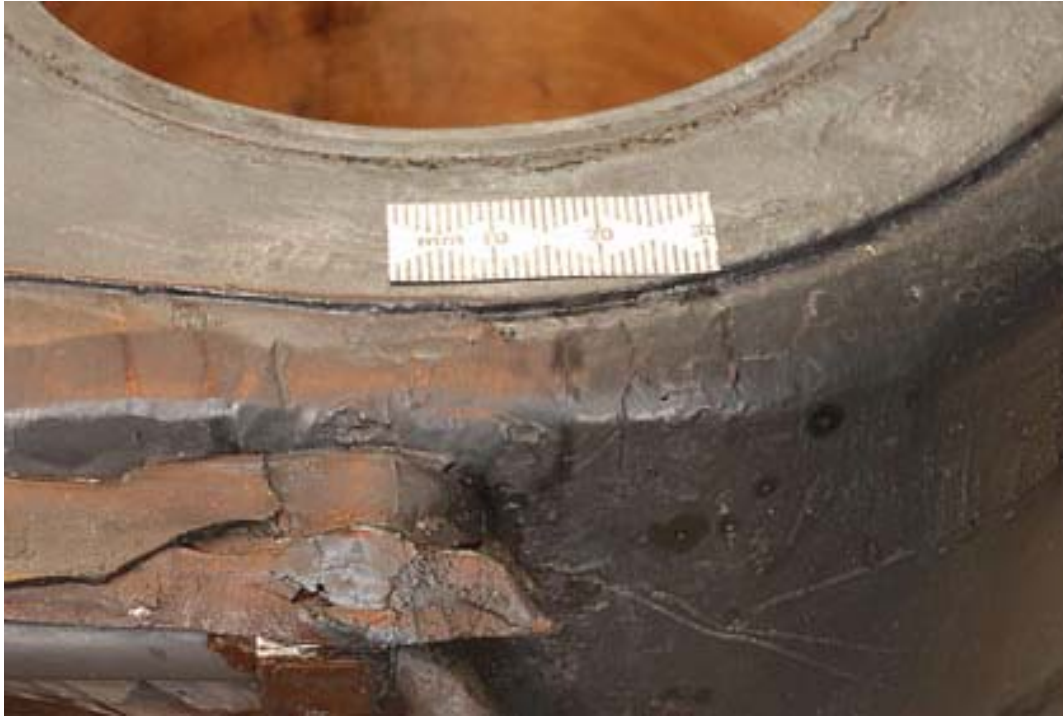
Figure 7, Example of a Root End Crack with Paint and Pad Removed

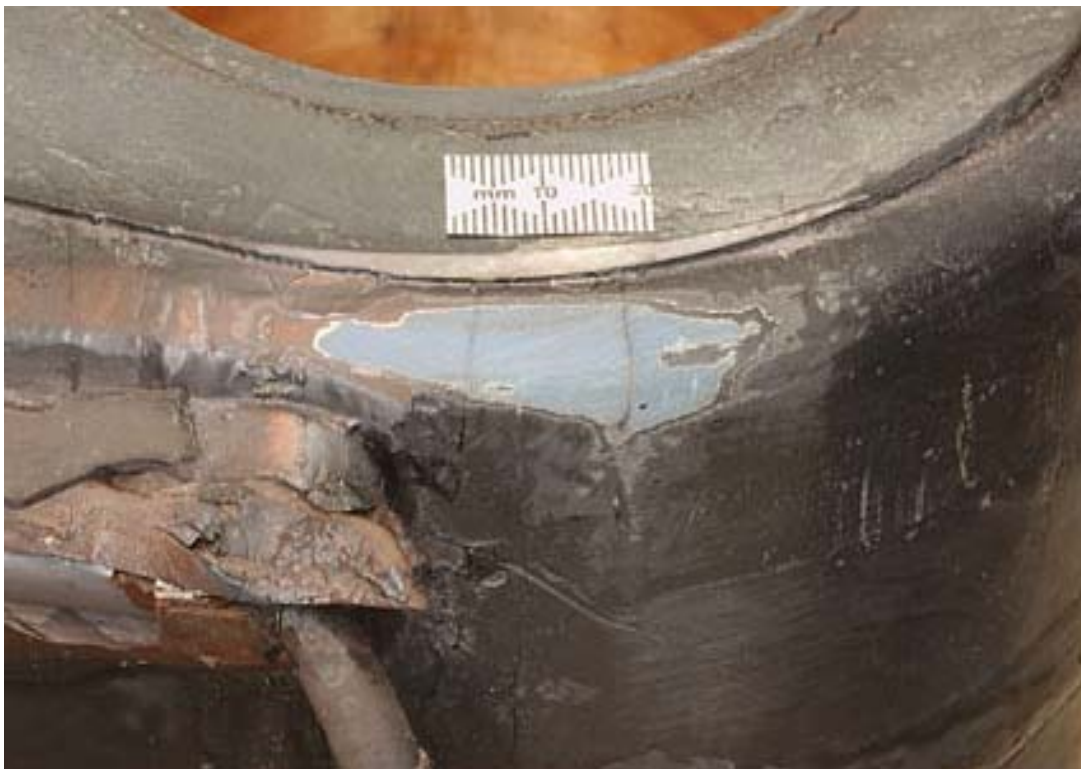
Figure 8, Example of an Un-sanded Root End Crack

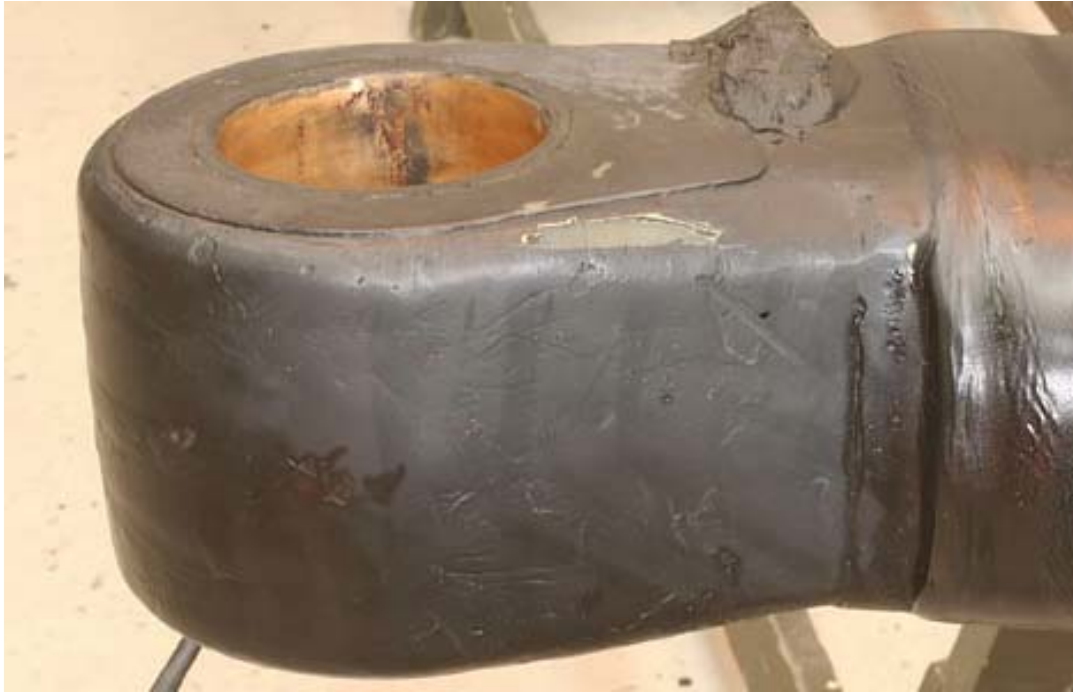
Figure 9, Example of a Sanded Root End Crack

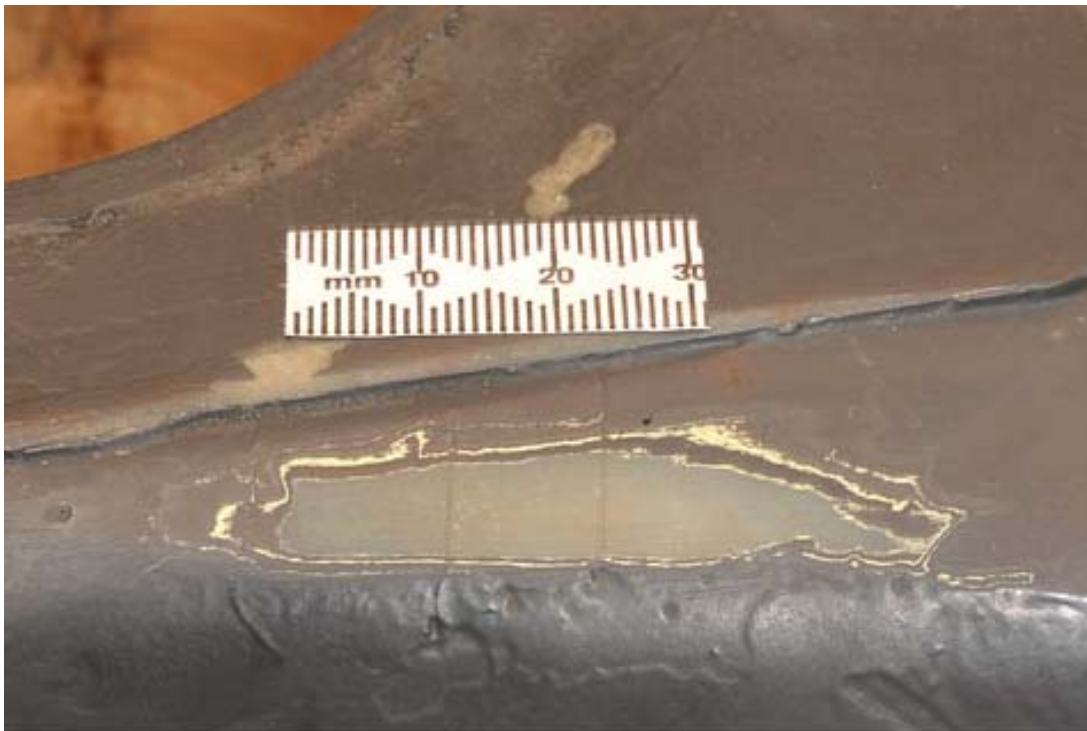
Figure 10, Example of a Sanded Root End Crack

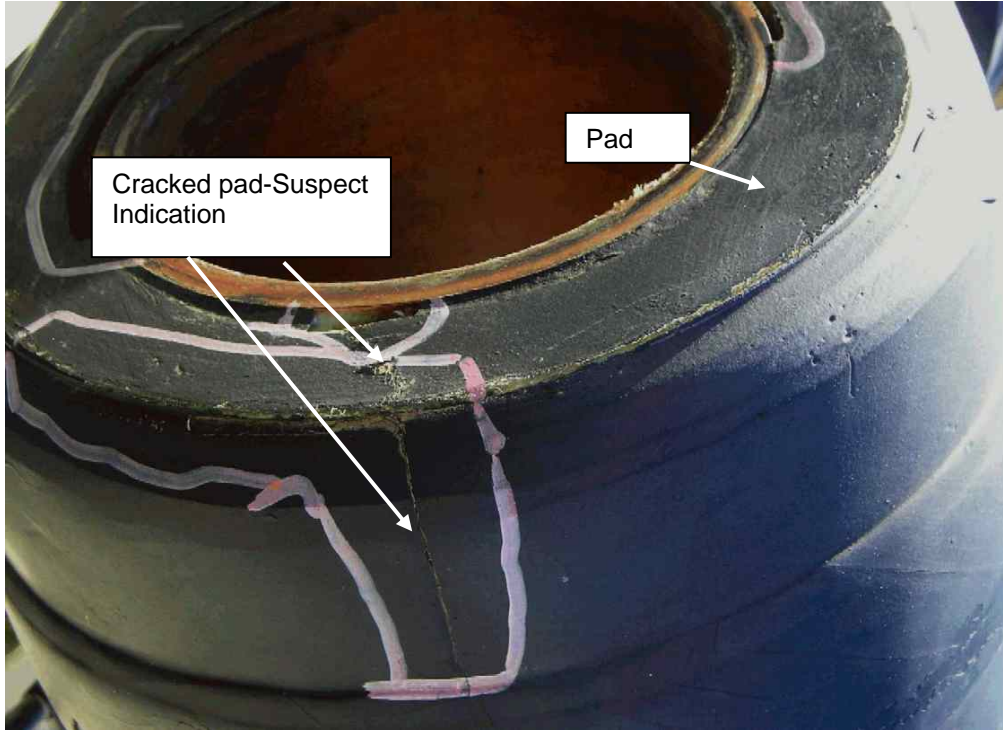
Figure 11, Example of a Sanded Root End Crack

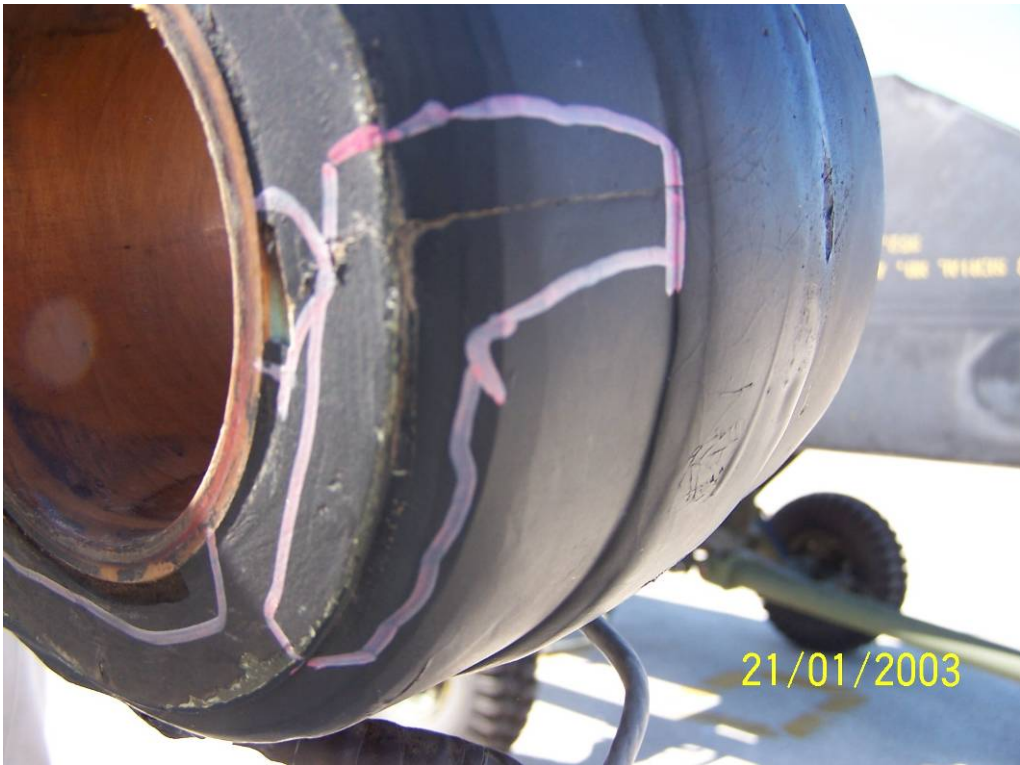
Figure 12, Example of Suspect Indication & Cracked Pad
