* EMPLOYEE BULLETIN

No. 75-38

November 25, 1975

UTTAS 001 ACCIDENT SEQUENCE ESTABLISHED- AIRCRAFT REPAIRABLE

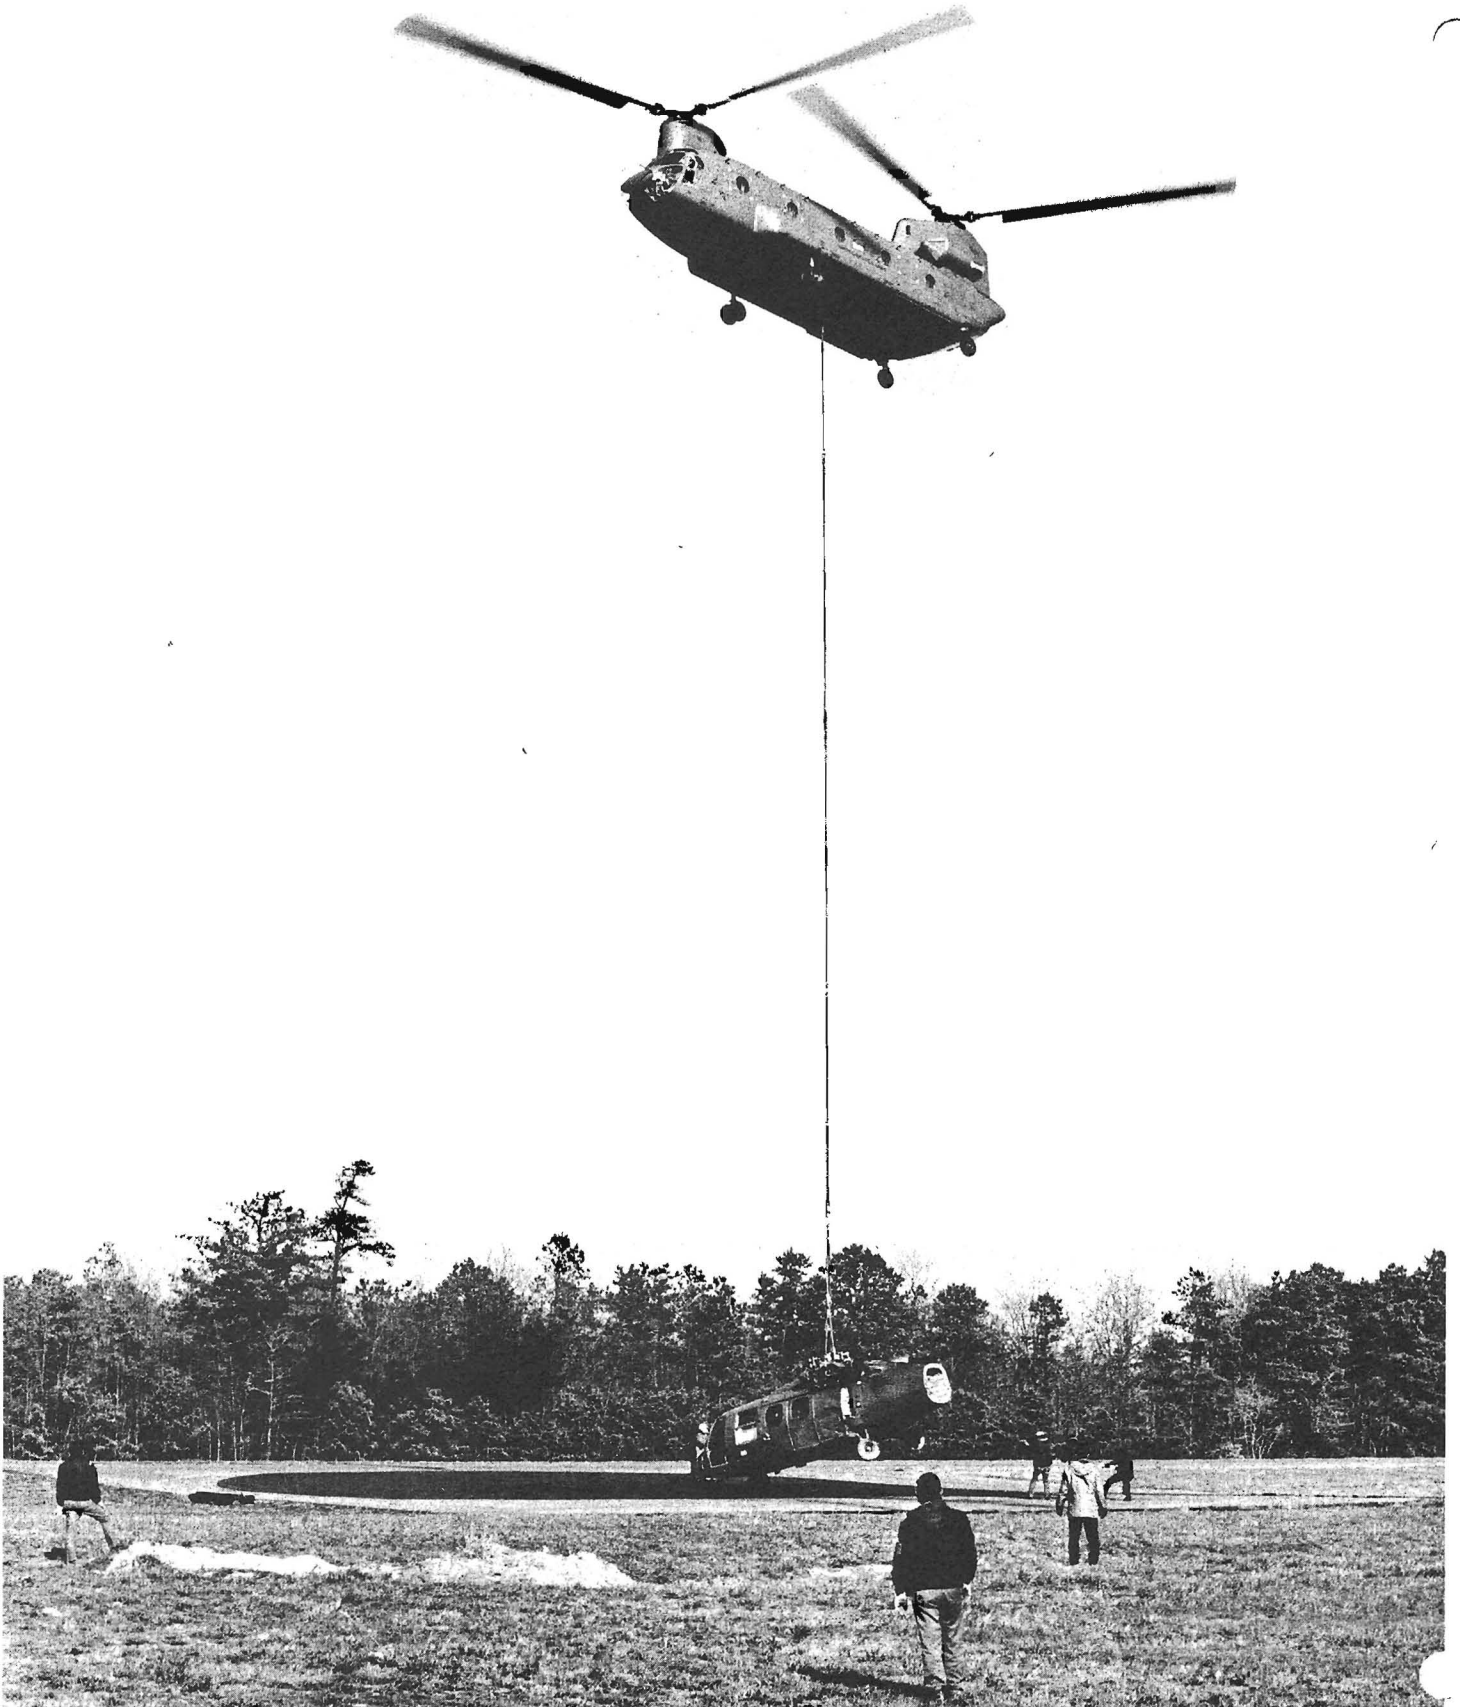
CH-47C Chinook, piloted by A. J. Hutto and Al Santa Maria, returns 001 UTTAS to Calverton flight test facility.

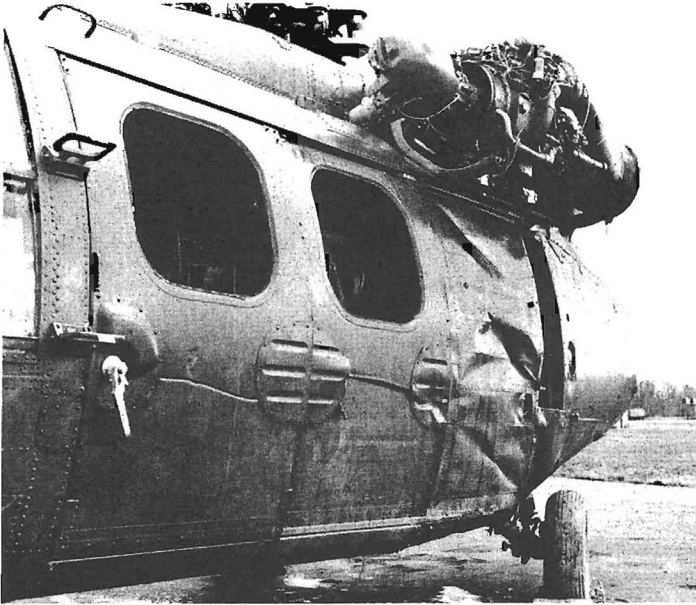
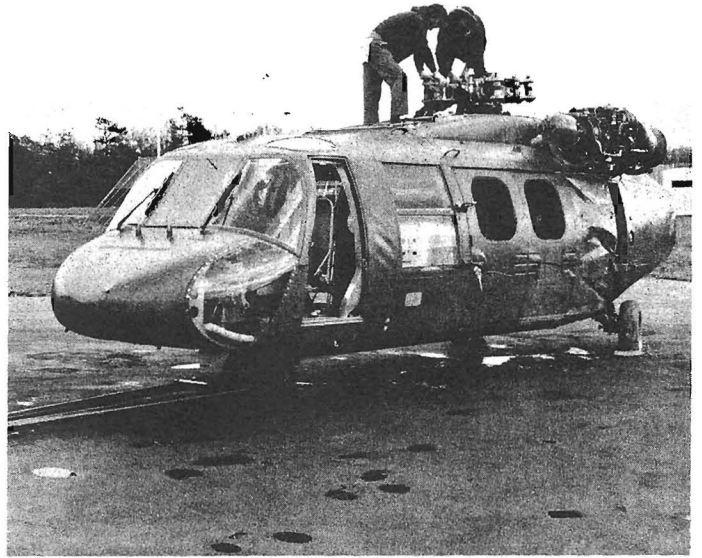
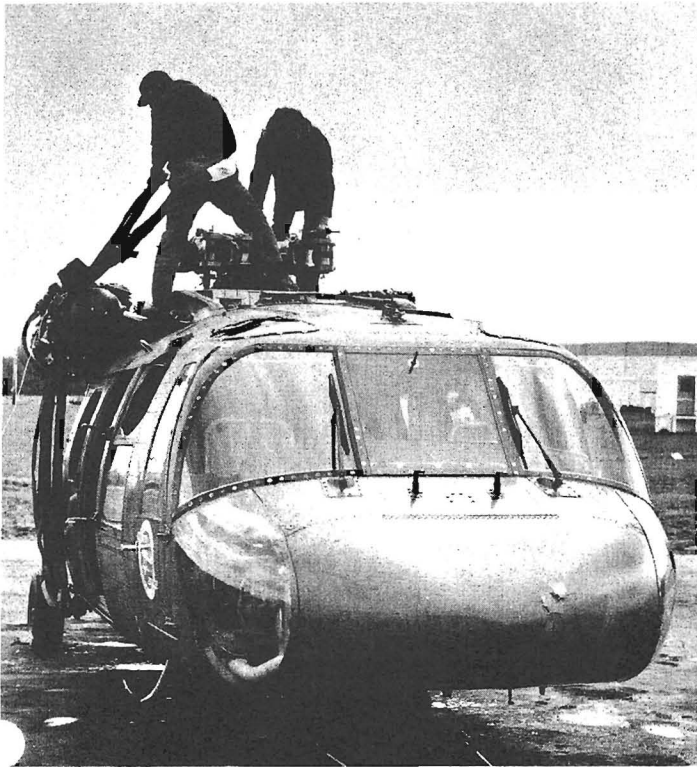
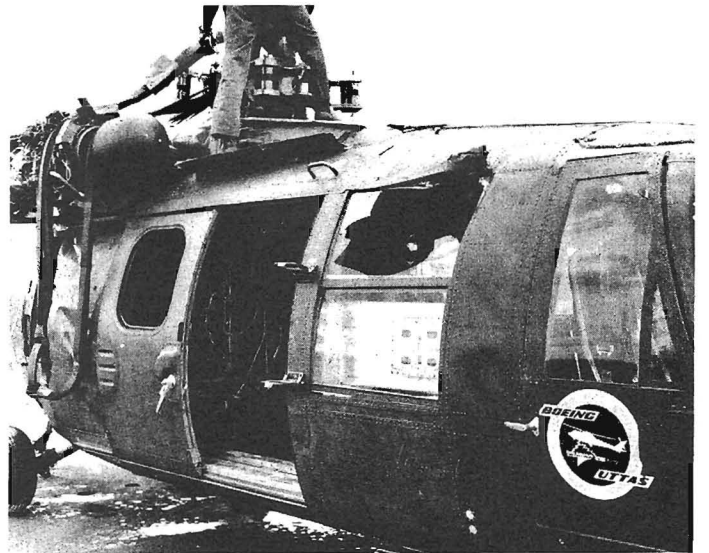
The main fuselage structure is essentially undamaged. The tail rotor has four blades still attached to the straps in proper connection to the tail rotor hub and shaft even though the tail boom broke loose from the aircraft. Based upon detailed examinations of the damaged aircraft, the company is recommending to the U. S. Army that 001 be repaired and returned to flight status.

During entry into the woods the main rotor blades and tail rotor blades contacted a number of oak trees ranging in diameter from 6" to 15". The transmission is firmly in place in the aircraft structure with no evidence of any movement of the transmission and transmission mounting structure. For example, it was possible to open the hatch immediately aft of the transmission with no evidence that any structural deformation of the butt line beams on which the hatch tracks are mounted had taken place.

The following photographs taken at the Calverton test center on Saturday, November 22, show the structural integrity demonstrated by the rotor system and airframe structure.
