(i) G-BWFC – No 1 engine and transmission gearbox installation
External indications of fire damage

Previous cases of Input Pinion Main Roller Bearing Failure

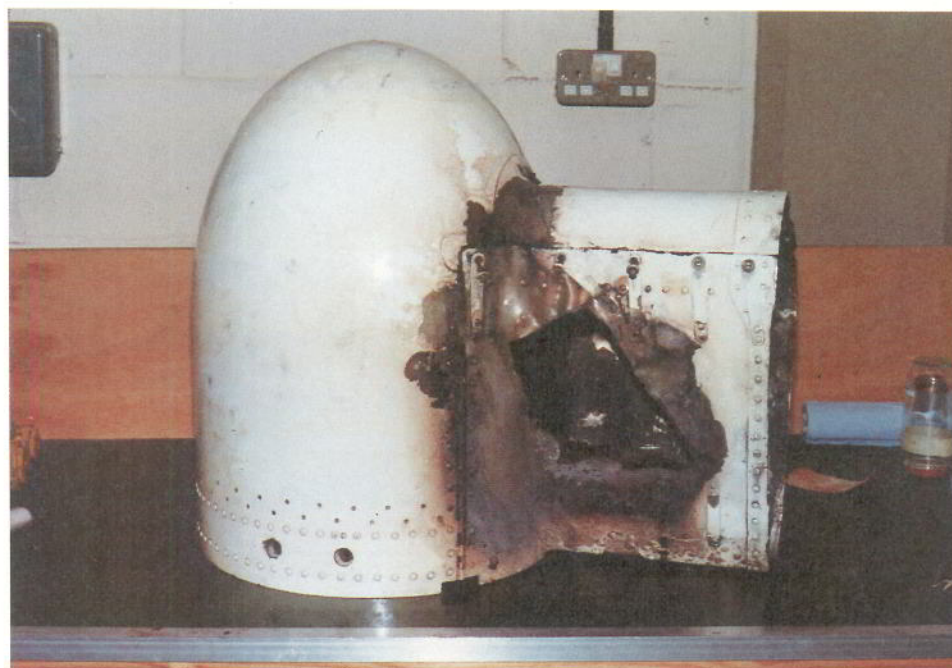
(ii) Fire damage: No 1 engine transmission gearbox fairing

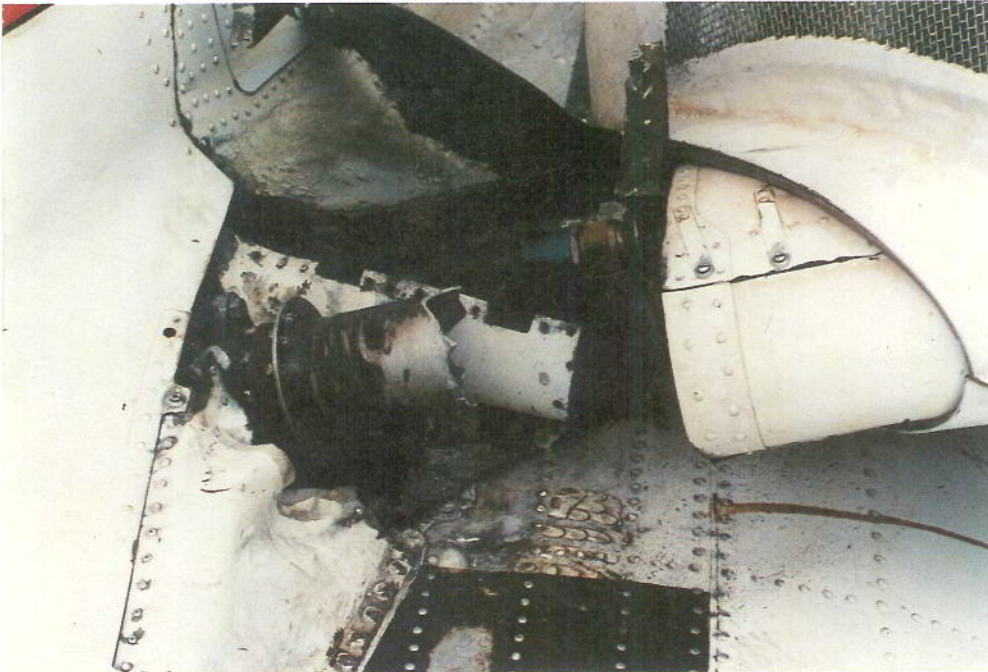
(iii) No 1 engine transmission driveshaft failure

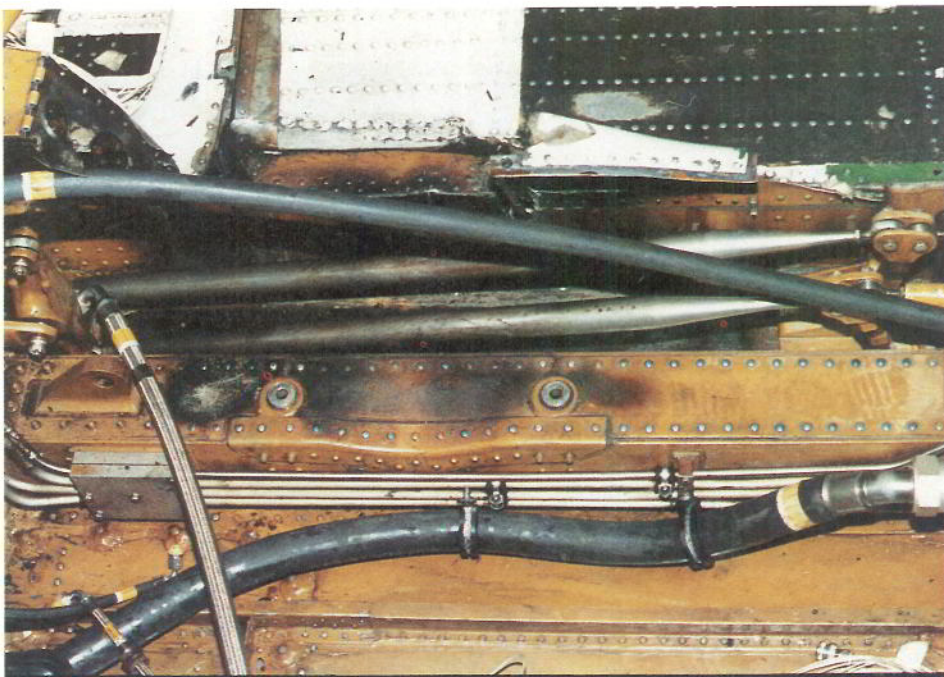
**(iv) Fire damaged structure in area of combining gearbox mounting
(Note damage to flight controls and transmission lubrication hoses)**

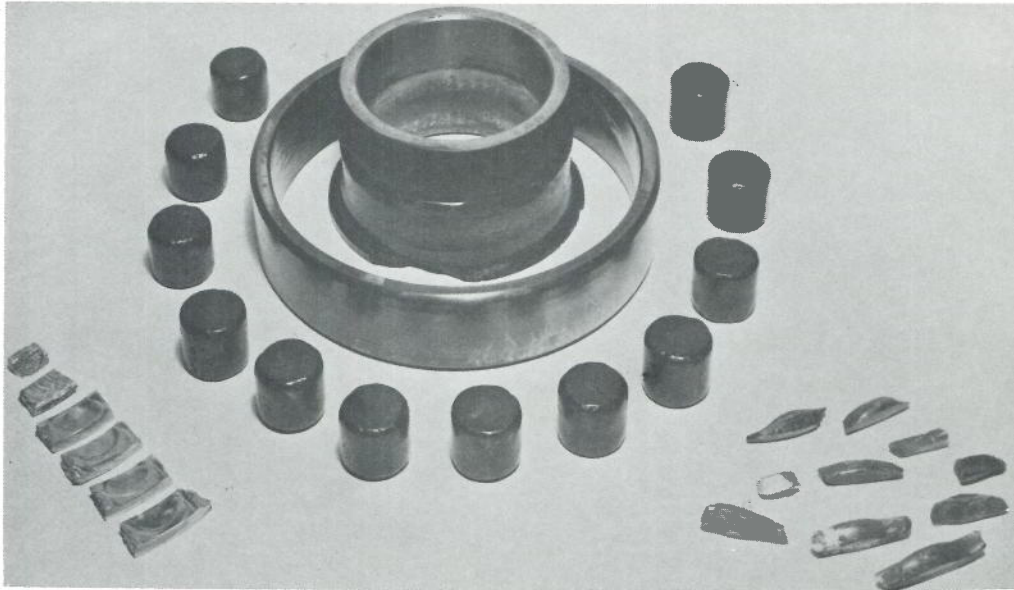
(i) Components and fragments from failed bearing

No 1 engine transmission gearbox input pinion main roller bearing

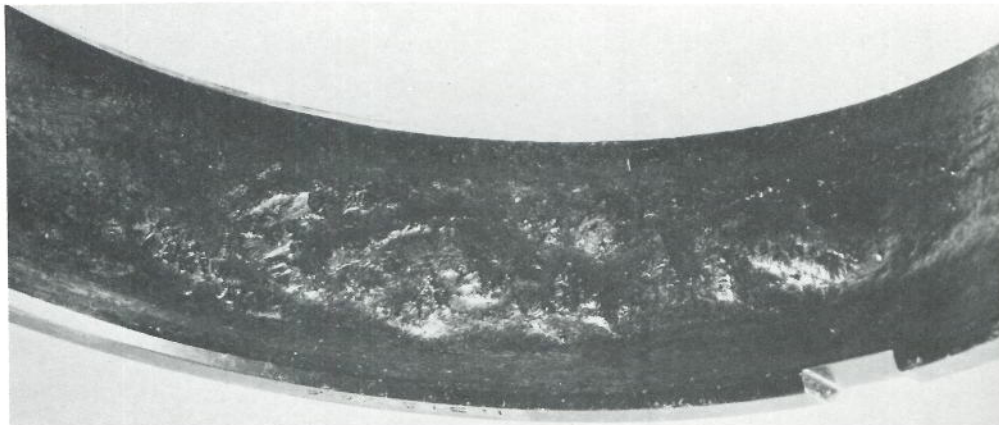
(ii) Damaged rolling surface of outer race

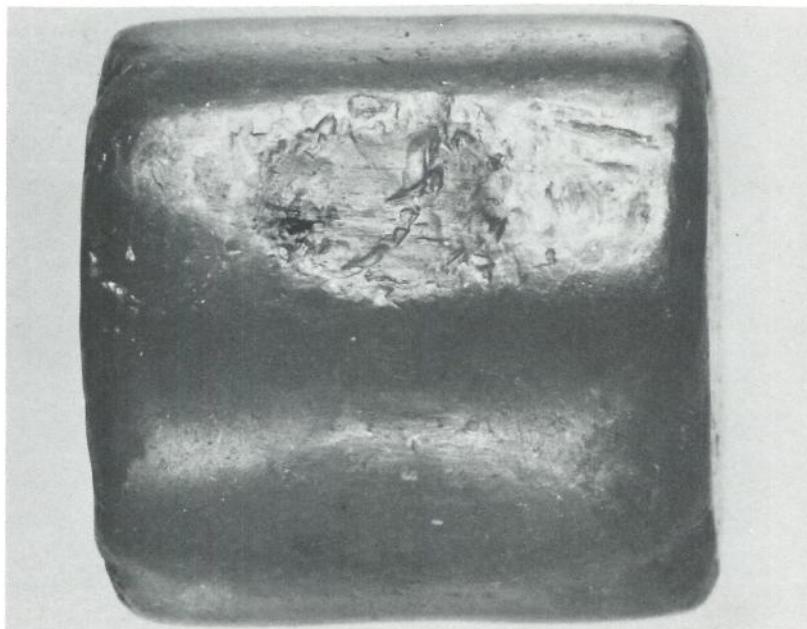
(iii) Typical example of roller damage
